**SAFETY RECOMMENDATION**

**Subject: serious incident occurred on September 9<sup>th</sup> 2010 to Antonov An-124-100 registration marks RA-82079 (equipped with Ivchenko Progress D18T engine series), Turin-Caselle airport (Italy).**

**Subject: accident occurred on Trieste-Ronchi dei Legionari airport (LIPQ) to the Diamond DA42 "TwinStar" registration marks S5-DNE, on April 11<sup>th</sup>, 2010.**

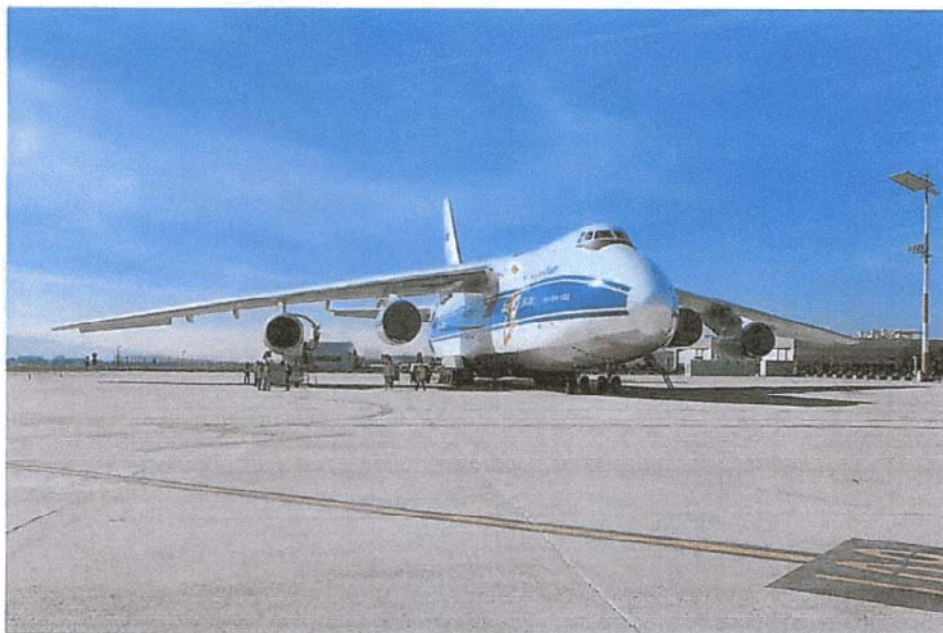
Picture 1: Antonov An-124-100 registration marks RA-82079.

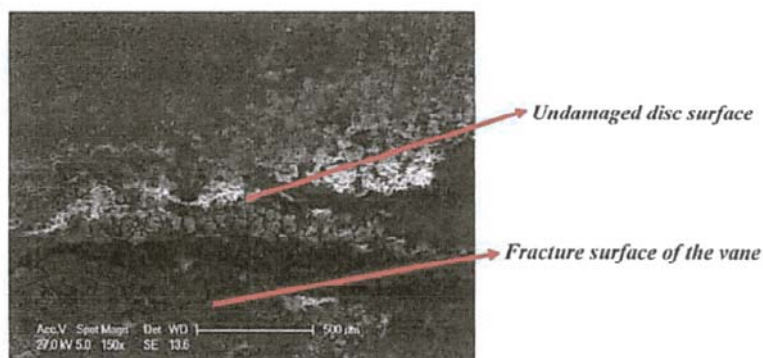
All the investigated fracture surfaces of the 5<sup>th</sup> stage showed a strong contamination. It is worth noting that the fracture surfaces of the vanes are characterized by a degree of surface alteration which is very similar to the one observed on the disc and on the undamaged vanes. An example is shown in figure 1 which refers to the fractured vane labeled as N° 2 (HPC 18T.01.05.050-03, 5<sup>th</sup> stage vanes, fragment of upper half-ring with vane N° 2 - fracture, attached to the external ring) and figure 2 which is an EDS spectrum of the surface of the disc of the specimen N° 1 (HPC 18T.01.05.050-03, 5<sup>th</sup> stage guide vanes with vane N° 2 - fracture surface, attached to the internal ring). In figure 1 has to be noted that the morphology of the undamaged disc surface (which has been exposed to operating conditions for a long time) and the one of the fracture surface of a vane are similar.

Figure 1: SEM micrograph of fracture surface of specimen N° 2.

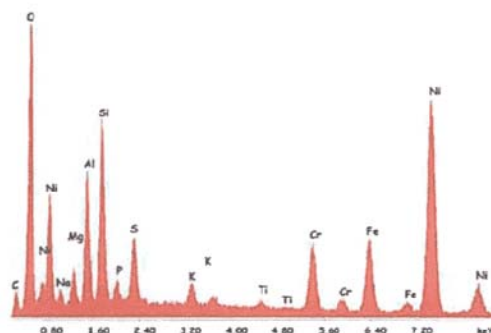
Figure 2: EDS spectrum of the disc surface for the specimen N° 1.

The low level of contamination characteristic of the fracture surfaces of both the impacted 5<sup>th</sup> stage vanes and 6<sup>th</sup> stage is therefore consistent with a short exposure time to high temperature and operating conditions of the compressor. Moreover, it was noted that the fracture surfaces of the 5<sup>th</sup> stage did not show a ductile behavior (at least when taking into account the morphology of the surface which is almost completely covered by thick deposits) and that a concentration gradient of the contaminants exists which is strictly correlated with the fatigue crack growth path. In fact, it was noted that the concentration of contaminants is higher where the crack originated (figure 4) and is lower in close proximity to the ultimate failure region where the EDS spectrum is comparable with one of the virgin alloy.

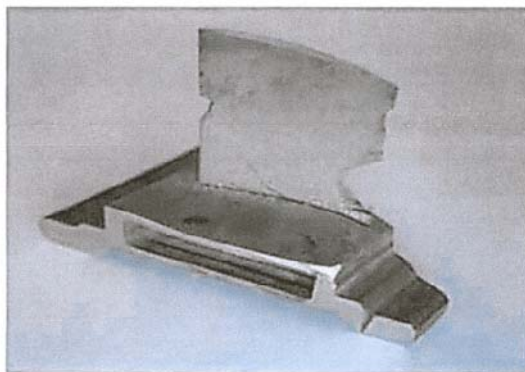
On the contrary, the stator vanes which have impacted signs appear to be heavily deformed (see figure 3). They show a ductile fracture surface and are contaminated to a lesser extent in comparison with the vanes fractured close to the zone of attachment to the ring. This fracture surface has features which are similar to the ones detected on the ductile fracture surfaces of the specimen of the 6<sup>th</sup> stage (disk fragment of HPC 18T.01.06.016-01 N° 680I 6<sup>th</sup> stage with fracture at the place of tenon disengagement from groove N° 94).

Figure 3: fragment of upper half-ring 5<sup>th</sup> stage with vane N° 1 - external ring.

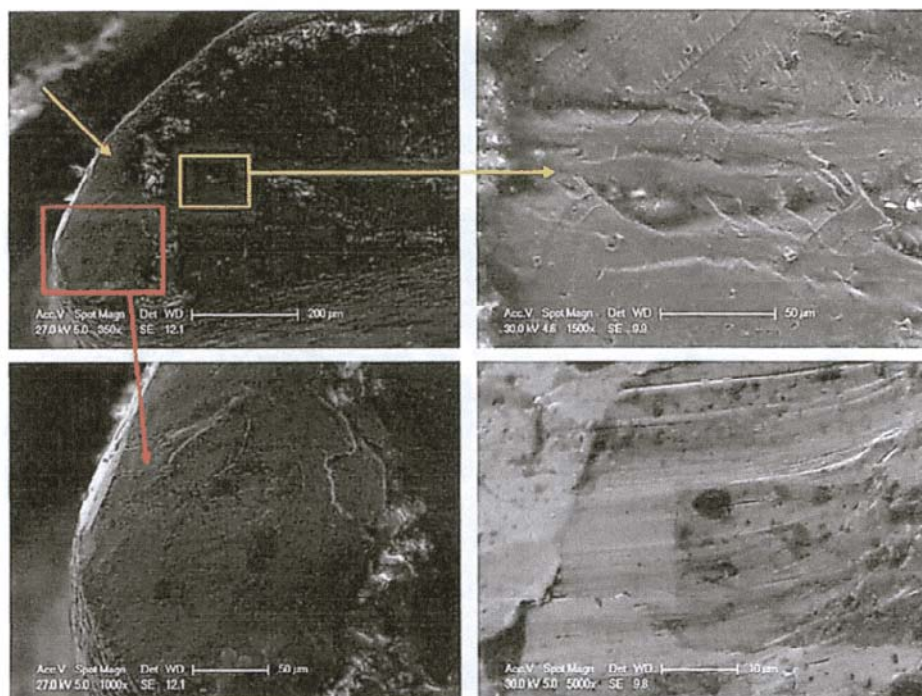
Figure 4: SEM micrographs of the fracture surface of specimen N° 2 showing fatigue striations.

This is likely to suggest that the fracture surfaces of the 5<sup>th</sup> stage have been subjected to the operating conditions for a longer period than those of the 6<sup>th</sup> stage. From the fractographic analysis it can be supposed that the fracture of the vanes of specimens N° 1 - 2 occurred prior to the catastrophic failure of the 6<sup>th</sup> stage.

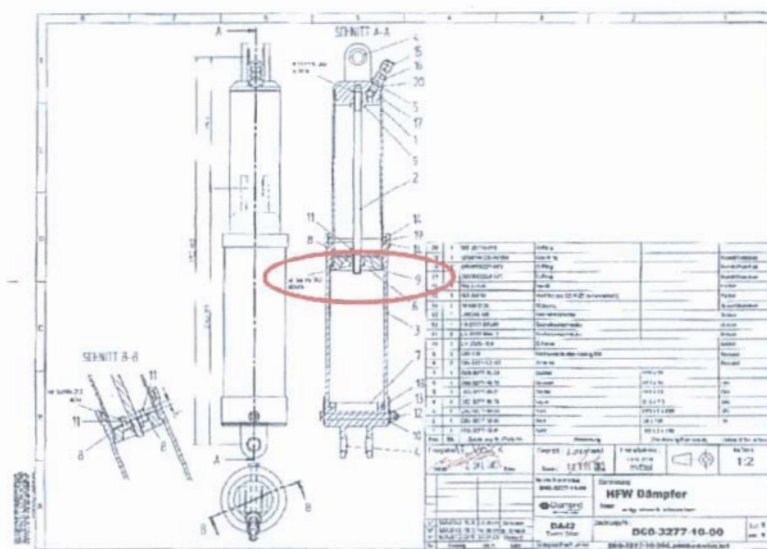
Figure 1: Main Landing Gear Dumper Scheme.

During visual inspection performed on the left main landing gear, an over-length of the related shock absorber has been noticed (P/N D60-3277-10-00, S/N 031623 34328 HEG). At the presence of the Diamond representative, the ANSV investigator asked to proceed with the component disassembly (see picture 2). The nut identified on the figure 1 as item "9" has been found completely unscrewed. Infact it has been found in the oil drained during the disassembly operation.

The nut loss, made the dumper longer than the project requirements, so after last retraction the landing gear remained locked in “up position” due to the interference between the wheel and the airframe (see picture 3).

As described by the AMM 32-10-00 (7.B. “Assemble Main Landing Gear Dumper”) of the aircraft, the installation of this nut need to «apply Loctite 262 on thread and tighten with 15 Nm (11 lb.ft.)» and the Loctite 262 data sheet contemplates its use in presence of oil of same type used in the dumper (see figure 2).

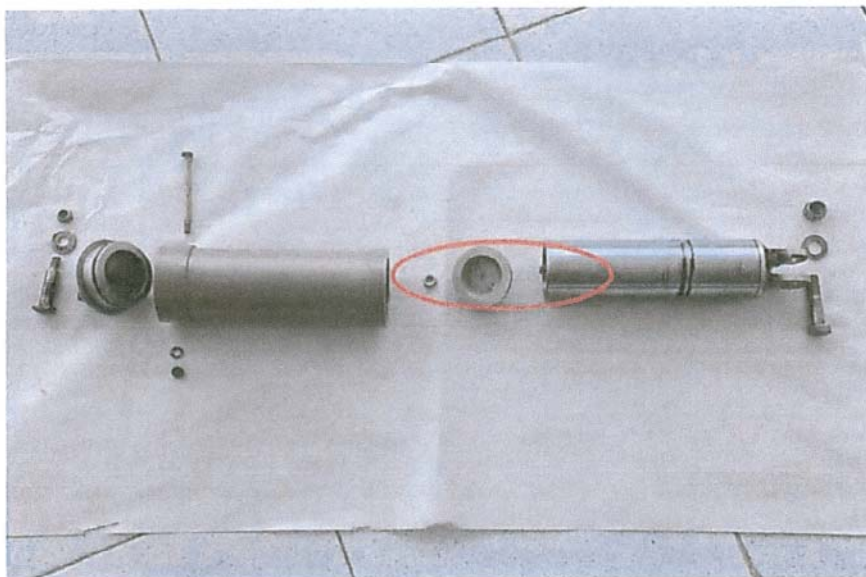
The microscope analysis showed the presence of “red residual” on the threads of item “2” in the position of item “9”.

FT-IR spectrum analysis on this “red residual” confirm that their chemical characteristics are compatible and comparable with Loctite 262.

Picture 2: left main landing gear shock absorber disassembled.
