**SAFETY RECOMMENDATION**

**Subject: serious incident occurred on September 9<sup>th</sup> 2010 to Antonov An-124-100 registration marks RA-82079 (equipped with Ivchenko Progress D18T engine series), Turin-Caselle airport (Italy).**

**Subject: accident occurred on Trieste-Ronchi dei Legionari airport (LIPQ) to the Diamond DA42 "TwinStar" registration marks S5-DNE, on April 11<sup>th</sup>, 2010.**

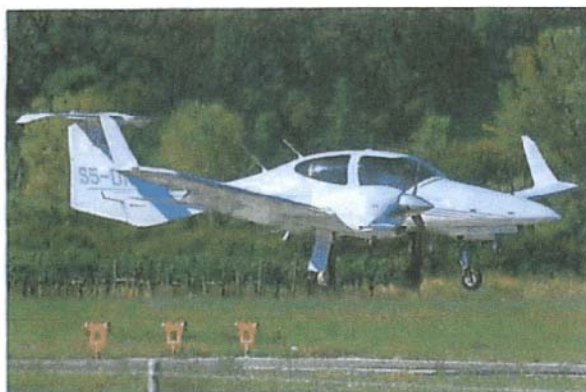
Picture 1: Diamond DA42 "TwinStar".

On April 11<sup>th</sup>, 2010, a Diamond DA42 "TwinStar" (picture 1) registration marks S5-DNE, due to landing gear extension problems during approach to Portoroz airport (LJPZ), diverted to Trieste-Ronchi dei Legionari airport (LIPQ) to land on a safer runway, with the left main landing gear not down.

The aircraft stopped safely on the runway and the emergency services on the airport approached the aircraft but no action has been needed. Minor damages to the aircraft, no damages to the airport and no injuries were reported. The aircraft was moved to a parking area through the use of a little crane.
